Representatives from the Russian Interregional Distributive Grid Company (IDGC) of Urals- "Chelyabenergo" branch has addressed to GIG division with a problem of periodic shutdown of segment on line. **Object:** HV 110 kV Rakitnaya-Aleksandrovskaya, insulators of PS70E (U70BS) type.

**Request:** To research the reason of string flashover and to work out measures for its prevention.

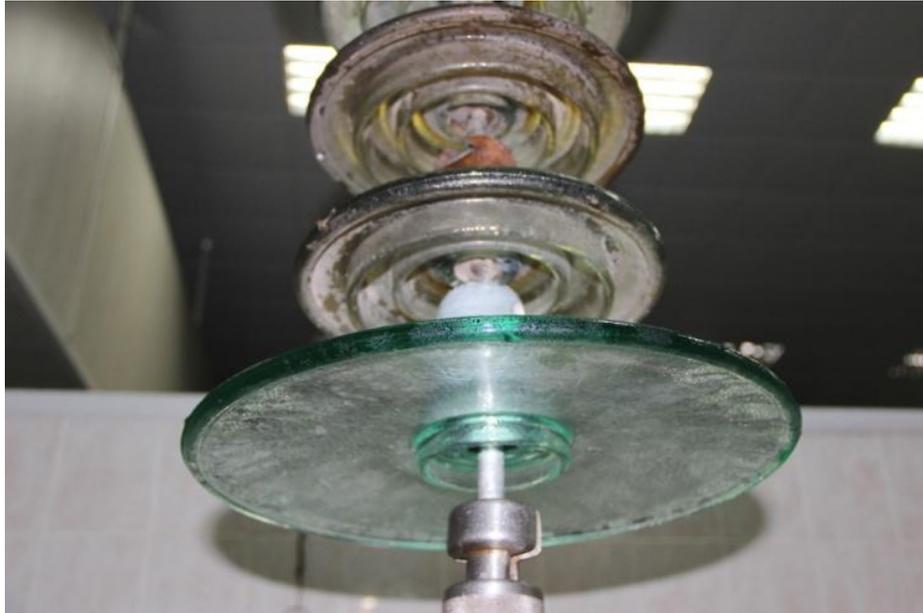
Fig.1 Test of new configuration string unit

As the insulating parts are polluted not only from the above but also from the below, it is recommended to protect it from both sides. Thus it is suggested to install insulators of aerodynamic profile from the above and below the string unit. Thanks to the insulating part of a larger diameter, aerodynamic insulators protect the string unit from pollution by external factors. To confirm it the comparison between discharge and withstand power frequency voltage (dry, wet, moisture (to simulate the dew) tests were conducted. Tests were conducted on the string unit of 5 insulators of PS70(U70BS) type removed from the line, string unit of 2 aerodynamic insulators of U120AD from the above and below and 3 insulators of PS70E (U70BS) type removed from the distribution lines, and string insulator unit of new insulators of PS70 type.

According to the test results discharge and withstand voltage (dry, wet, moisture) of the mixed type string insulator unit is higher than string unit of one type insulators.

1. Application of mixed type string insulator units including aerodynamic profile.
2. Cleaning from time to time insulators from contaminations in the overhead lines.

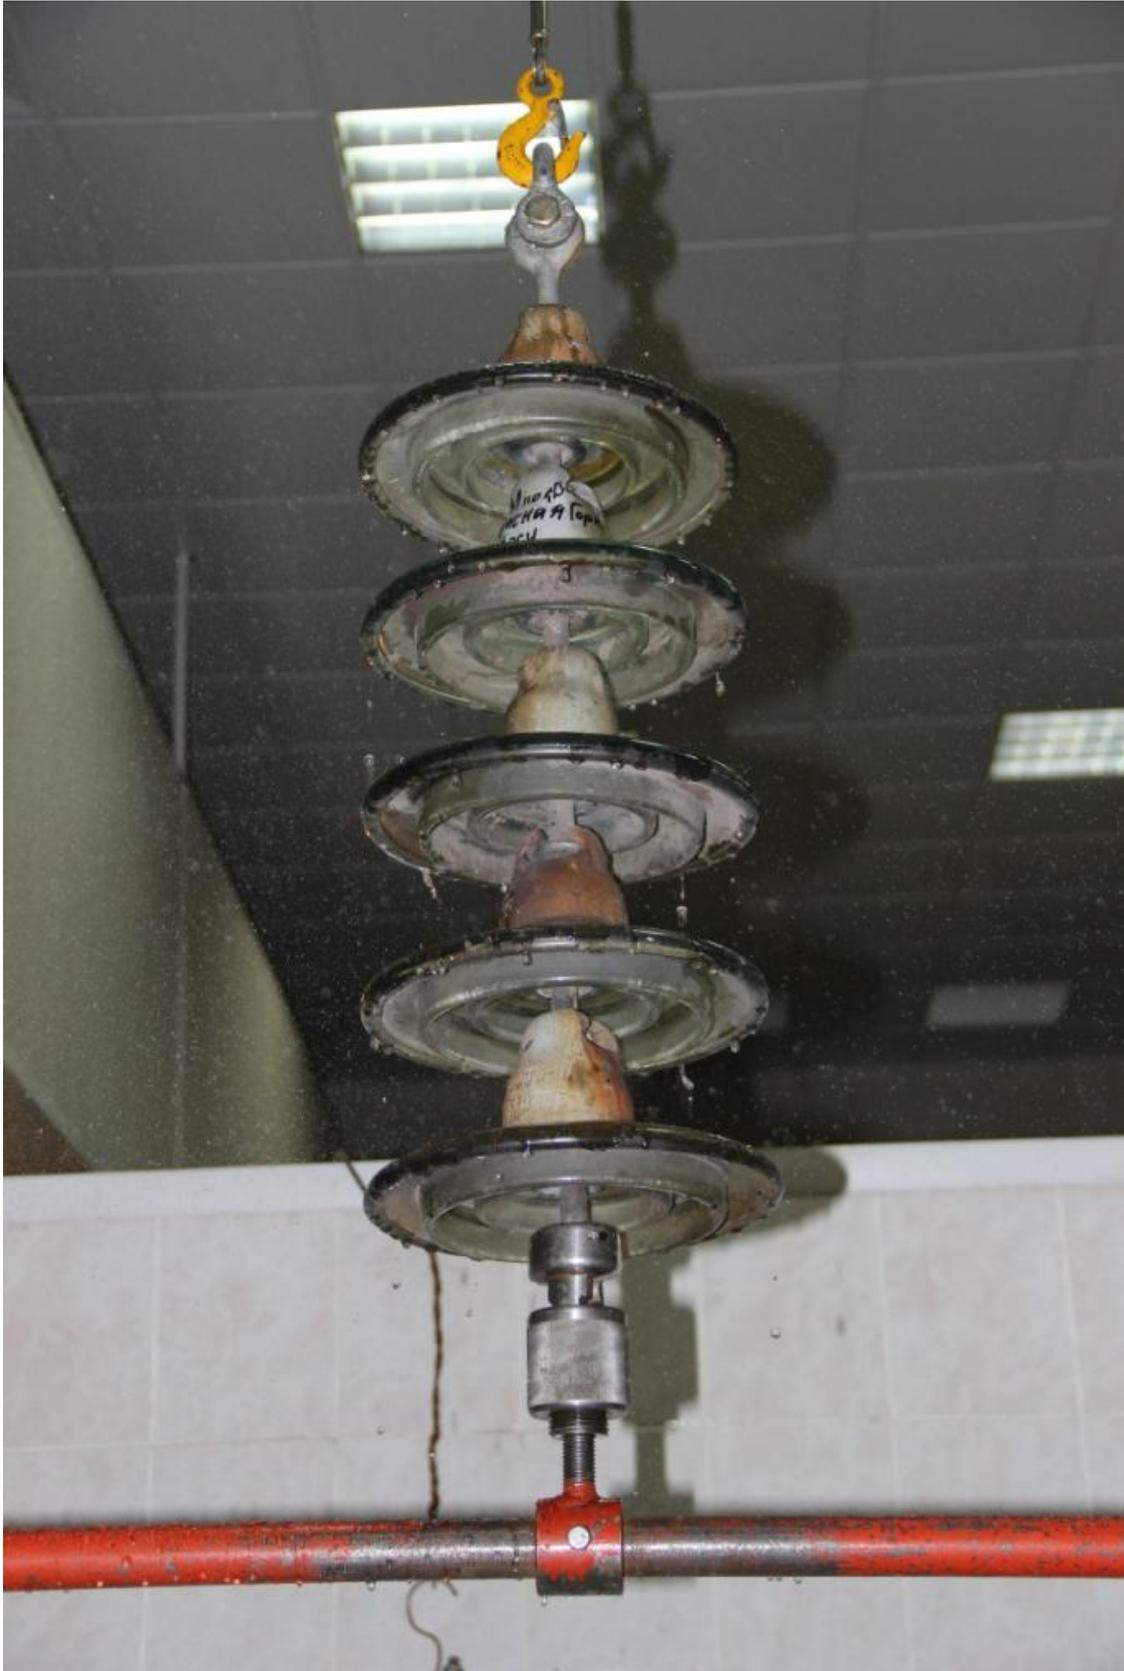
**Fig. 3 Tests (wet) of insulator previously used.**

Tests of the removed insulators of PS70(U70BS) type showed that discharged voltage (dry) of single insulators is 3% lower than new insulators, wet– 18% lower.

The discharge voltage (dry) of the removed string insulator unit is 3% lower than the new string unit, wet – 10% lower, moisturizing – 30% lower. The main reason of decrease of discharge characteristics of polluted insulators in dry and dew fall condition is humidification of the polluted layer. Water penetration is common for this type of pollution and leads to the loss of insulation characteristics.
