Representatives from the Russian Interregional Distributive Grid Company (IDGC) of Urals- "Chelyabenergo" branch has addressed to GIG division with a problem of periodic shutdown of segment on line. **Object:** HV 110 kV Rakitnaya-Aleksandrovskaya, insulators of PS70E (U70BS) type.

**Request:** To research the reason of string flashover and to work out measures for its prevention.

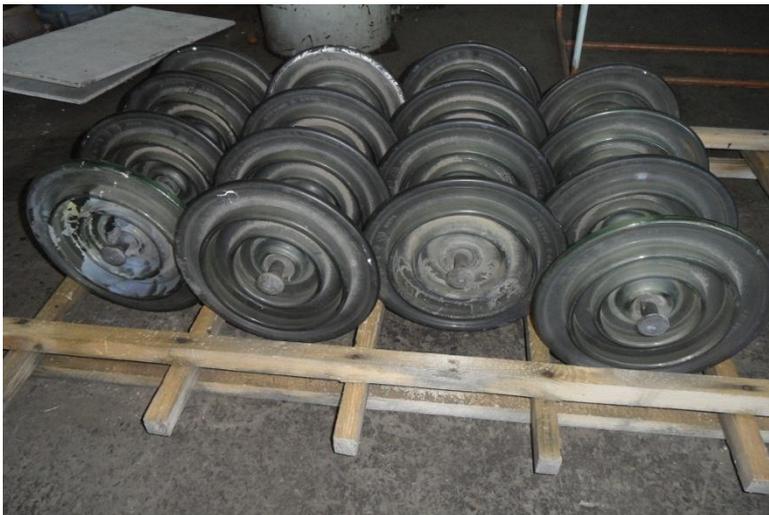
Flashover of string glass insulator units manufactured by OAO "YuAIZ" in 1983-1986 was observed during the inspection of overhead lines. Trace contaminations of grey-brown color, trace of flashover, lots of spider web along the string and between phases were observed.

While the shutdown segment is located in the agricultural area, chemicals conducive to insulation pollution were not used. Reportedly, the reason of shutdown of 110 kV Rakitnaya-Alexandrovskaya overhead line is the insulation flashover occurring along the wetting spider web when the dew falls.

As the insulating parts are polluted not only from the above but also from the below, it is recommended to protect it from both sides. Thus it is suggested to install insulators of aerodynamic profile from the above and below the string unit. Thanks to the insulating part of a larger diameter, aerodynamic insulators protect the string unit from pollution by external factors. To confirm it the comparison between discharge and withstand power frequency voltage (dry, wet, moisture (to simulate the dew) tests were conducted. Tests were conducted on the string unit of 5 insulators of PS70(U70BS) type removed from the line, string unit of 2 aerodynamic insulators of U120AD from the above and below and 3 insulators of PS70E (U70BS) type removed from the distribution lines, and string insulator unit of new insulators of PS70 type.
